How-to: Debugging a Low-Powered RF Transmitter

by Jim Pearce
Pegasus Technologies, Inc.

We were recently commissioned to redesign a remote control transceiver operating in the 902-928 MHz license-free US band. The client had an operable unit, but its output spectrum was so ugly that the possibility of passing FCC certification testing was nil.

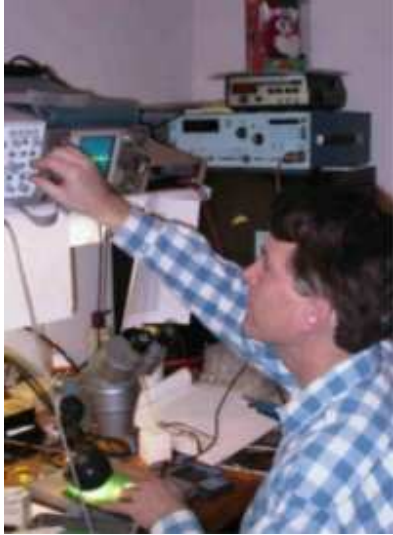
Debugging a board in the lab
